AFRL-ML-TY-TR-2004-4528

**AFPDS Bagged Propellant Fire Suppression
Evaluations**

Steven Wells, Applied Research Associates, Inc.
P.O. Box 40128
Tyndall AFB, FL 32403

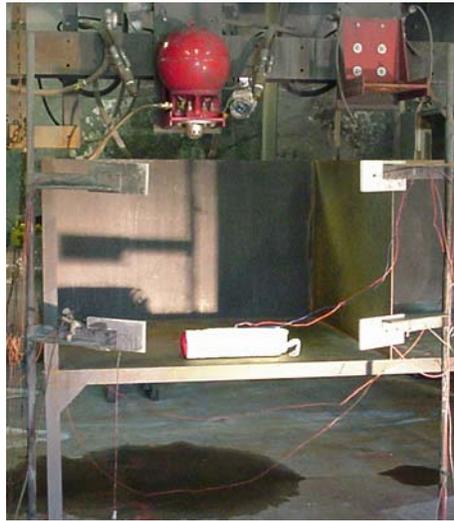
Figure 1: Suppression System and Table with M3 Propellant

All evaluations were conducted in the NATO facility at AFRL/MLQ Test Range II. This test facility was set-up with an AFPDS suppression system. The suppression system consisted of one 10L sphere extinguisher, two 1¼-inch Pyrotech solenoid nozzles and one Fire Sentry high-speed flame detector. The bottom of the sphere nozzle was located 35 inches above the table and the solenoid nozzles were 42 inches above the table. The flame detector was mounted 12 inches behind the sphere nozzle and 40 inches above the table.

An existing table was placed under the suppression system and the propellant was placed on this table. The table top was ¼-inch steel with dimensions 52 inches wide and 48 inches deep. The table had three 30-inch high, ¼-inch steel walls. Initial plans were to conduct two suppressed fires on the table, then to remove the left and right walls and continue with the remaining fires. However, the initial fires were not extinguished immediately. The propellant bags were forced off of the table by the water spray and continued to burn or reignited after they were outside of the protection of the water spray. The decision was made to keep the walls in place for the remaining evaluations and to add a four-inch rim to the table edge to contain the propellant and the water.

One bag of M3 propellant was located on the table, 35 inches below and 30 inches in front of the sphere nozzle (See Figures 1 and 6). The M3 bag consists of five charges, three small charges in the middle and two large charges on the outside. A single electric match failed to ignite the material; so two electric matches were connected in parallel. After ignition, the fire was detected 34 ms after the detectable event. Water discharged from the sphere 36 ms after the detectable event. Due to the location and size of the fireball, the fire was never contained, and although the water spray impacted the propellant, the density was not great enough to extinguish the fire. The spray did prevent the fire propagation to the two outside propellant charges that remained intact after the test. The propellant was pushed off the table and continued to burn on the floor for six seconds. Afterwards the propellant grains from the three inside charges were scattered across the floor in front of the table.

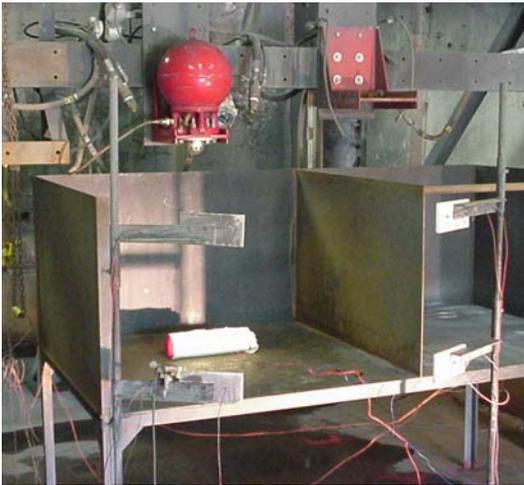
Figure 8: Suppression System and Table with M3 Propellant

One bag of M3 propellant was located on the table, 35 inches below and six inches in front of the sphere nozzle (See Figures 8 and 9). The bag was moved closer for this test to determine the effect on suppression. Two electric matches were used to ignite the material. After ignition, the fire was detected 23 ms after the detectable event. Water discharged from the sphere 25 ms after the detectable event. The initial fireball was contained almost immediately and suppressed 24 ms after flame detection. However, at some point the material that washed off the table reignited on the floor and went out 1.5 seconds after ignition (Evidence of this flame was recorded on video and measured by thermocouples on the floor). Most of the propellant residue remained on the table including the two outside propellant charges that remained intact. The propellant remaining after the test was approximately equivalent to that in Test 1 with a small portion on the floor.

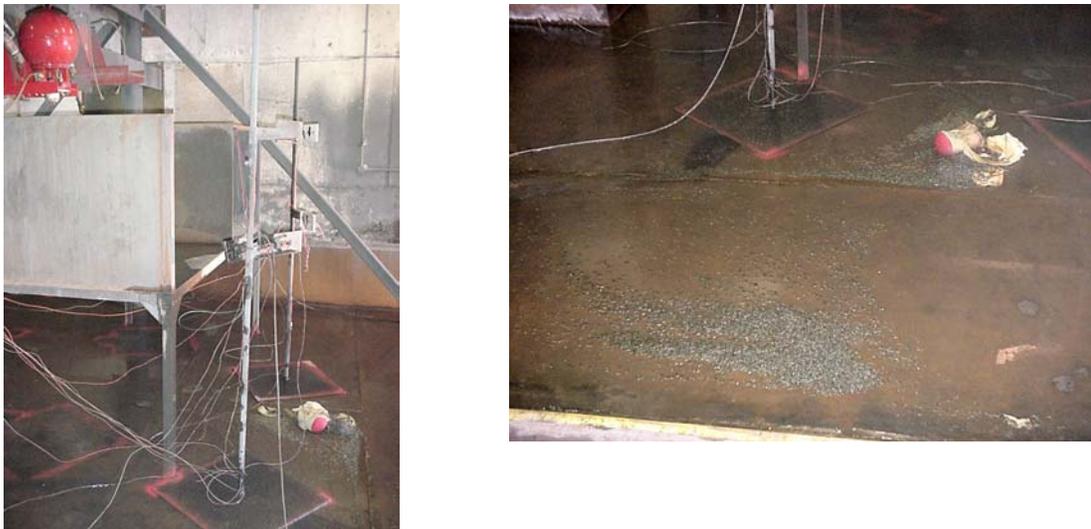
Figure 11: Test 3 Results

This was a repeat of Test 1. One bag of M3 propellant was located on the table, 35 inches below and 30 inches in front of the sphere nozzle (See Figures 1 and 6). A single electric match (different manufacturer than test 1) was used to ignite the material. After ignition, the fire was detected 22 ms after the detectable event. Water discharged from the sphere 24 ms after the detectable event. The fire appeared to be suppressed 60 ms after detection, however the flame came back 213 ms after detection with a fireball over seven feet high. Again, the low density of water spray contributed to the fireball coming back with such intensity. The fire went out eight seconds after detection. Afterwards, propellant grains from the three inside charges and one outside charge were scattered across the floor in front of the table. The remaining outside charge remained intact.

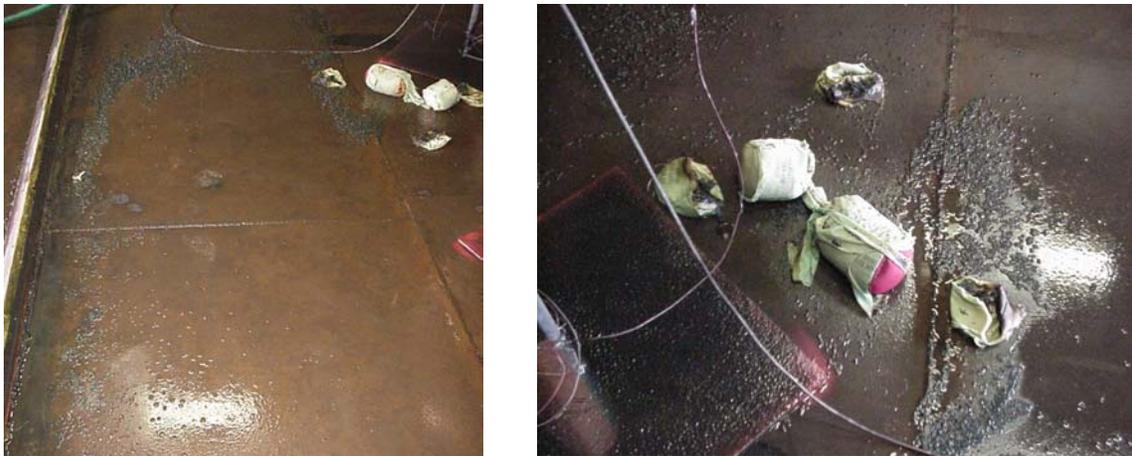
Figure 12: Test 4 Results

This was a repeat of Test 2. One bag of M3 propellant was located on the table, 35 inches below and six inches in front of the sphere nozzle (See Figures 7 and 8). A single electric match was used to ignite the material. After ignition, the fire was detected 24 ms after the detectable event. The fire was suppressed on the table 35 ms after detection, however as in Test 2, the fire reignited on the floor. Unlike Test 2, all of the propellant was washed off the table. The fire went out five seconds after detection. Afterwards, propellant grains from the three inside charges were scattered across the floor in front of the table. The two outside charges remained intact.

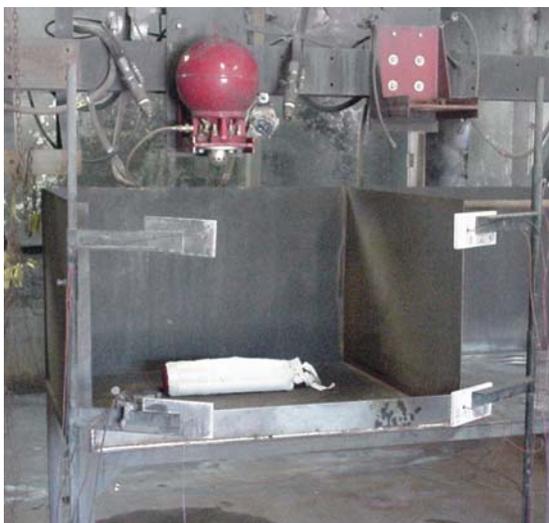
Figure 13: Tests 5-7 Setup

After Test 4, the table was modified with a four-inch tall, $\frac{1}{4}$ -inch steel rim. The rim was installed to contain the propellant and prevent combustion of propellant that is washed onto the floor. Also, the propellant was placed as shown in Figure 13 for the remaining evaluations. This modification worked so well that it is recommended for all applications involving munitions inspections on tables.

One bag of M4 propellant (13 lbs) was located on the table, 35 inches below and six inches in front of the sphere nozzle (See Figure 13). After a single electric match did not ignite the propellant, 10g of smokeless powder was added to the match to ignite the

One bag of M3 propellant (5.5 lbs) was located on the table, 35 inches below and six inches in front of the sphere nozzle (See Figure 13). A single electric match was used to ignite the propellant. After ignition, the fire was detected 23 ms after the detectable event and suppressed 25 ms after detection. The four-inch rim prevented the propellant bag and most of the grains from washing off the table. A few grains did end up on the floor as seen in Figure 15. The propellant bag sustained more damage than in other evaluations. Propellant grains from the three inside charges and one outside charge were scattered around the table. The other outside charge remained intact.

One unsuppressed burn of M4 propellant (13 lbs) was conducted to determine the effect of the suppression system. The propellant was located on the table, 35 inches below and six inches in front of the sphere nozzle (See Figure 13). An electric match with 10g of smokeless powder was used to ignite the material. The material burned completely.

The four-inch rim that was added to the table aided in containing the water and propellant together and kept the propellant bag within the protection area provided by the water spray. More propellant grains were wet by the water spray after this modification which prevented their ignition and burning.

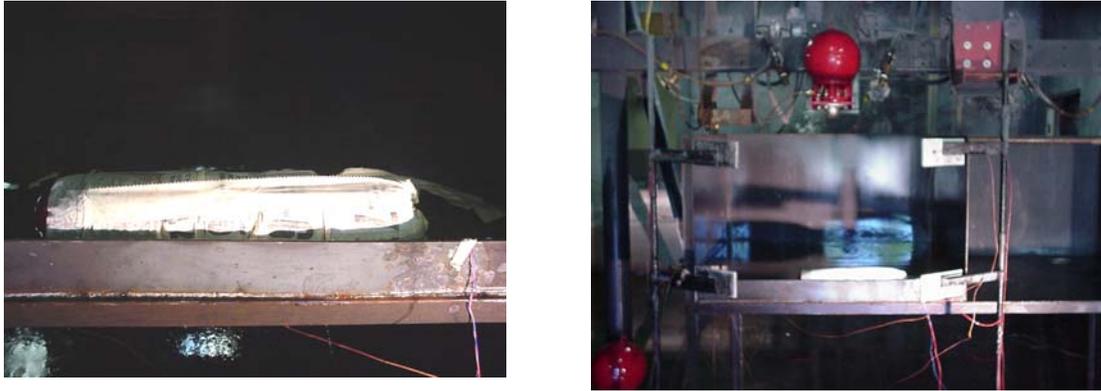
Figure 14: Test 5 Results

material. After ignition, the fire was detected 21 ms after the detectable event. The fire was suppressed on the table 29 ms after detection. The propellant bag remained intact and the four-inch rim on the table prevented the bag from washing off the table. The propellant in the M4 bag is larger than the M3 bag and may have made this fire easier to extinguish.

The M4 propellant used in Test 5 was easily extinguished by the AFPDS. Figure 4 shows that the M4 propellant grains were larger than the M3 grains. In the limited fires, the M4 appeared to propagate slower when burning. This slower propagation should make the material easier to extinguish. There were no remains of the M4 after the unsuppressed fire.

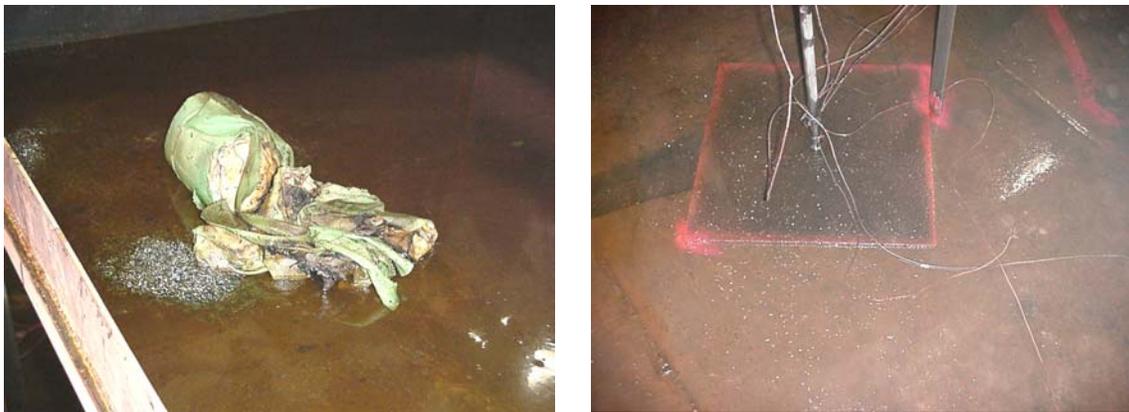
Figure 15: Test 6 Results

There was more smoke generated in this test than in other tests. It appears from the video that the material in the bag smoldered after extinguishment generating a significant amount of smoke.

After modifying the table with a four-inch rim, the last M3 fire, in Test 6, was extinguished 25 ms after flame detection. The propellant bag sustained more damage in Test 6 than in other evaluations, however, the fast and thorough extinguishment of the propellant showed a greater level of protection for workers in the area.
