Collision With Trees on Final Approach
Federal Express Flight 1478
Boeing 727-232, N497FE
Tallahassee, Florida
July 26, 2002

Aircraft Accident Report

NTSB/AAR-04/02

NTSB/AAR-04/02
PB2004-910402
Notation 7501B
Adopted June 8, 2004

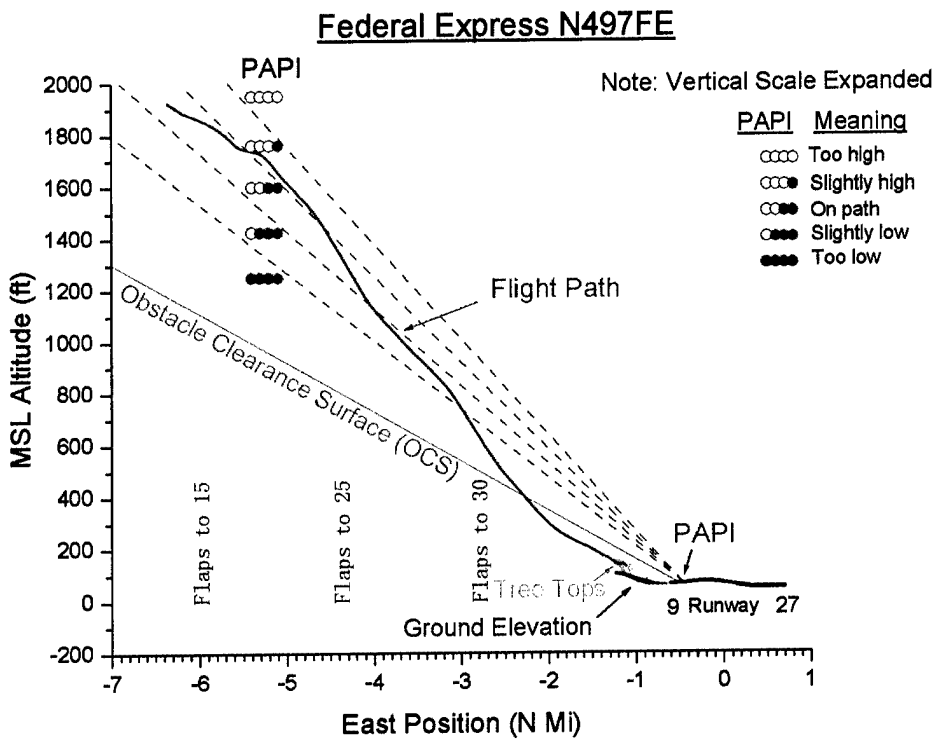
Figure 1. Descent profile of FedEx flight 1478.

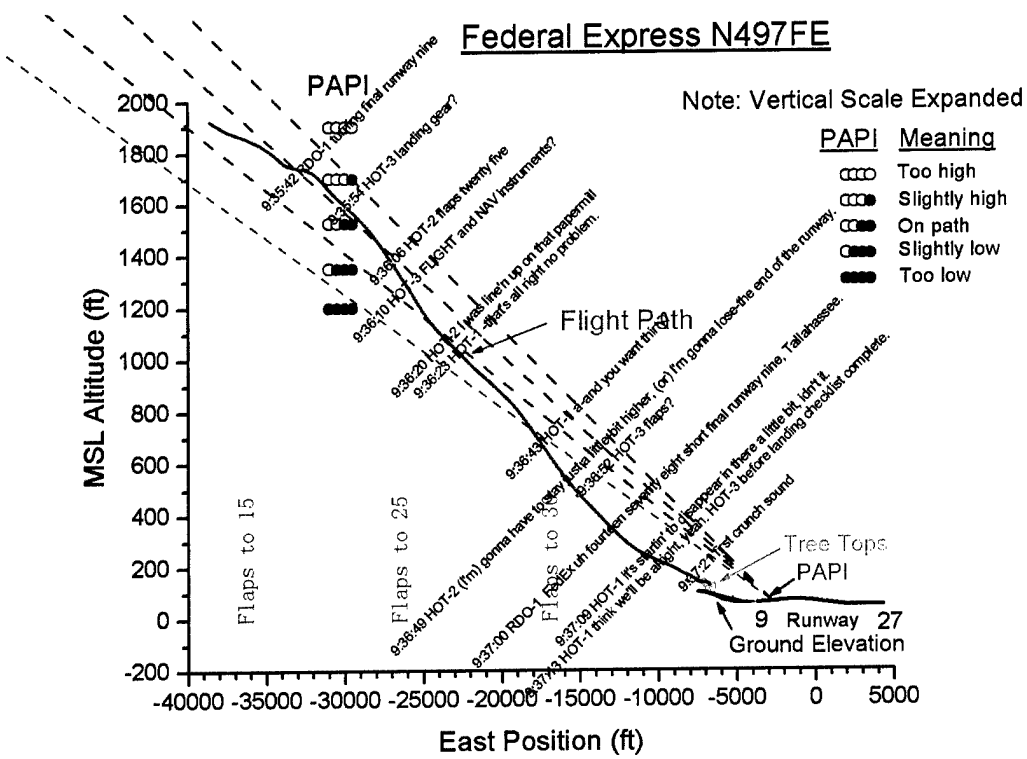
Figure 2. Descent profile of FedEx flight 1478, with select CVR comments overlaid.

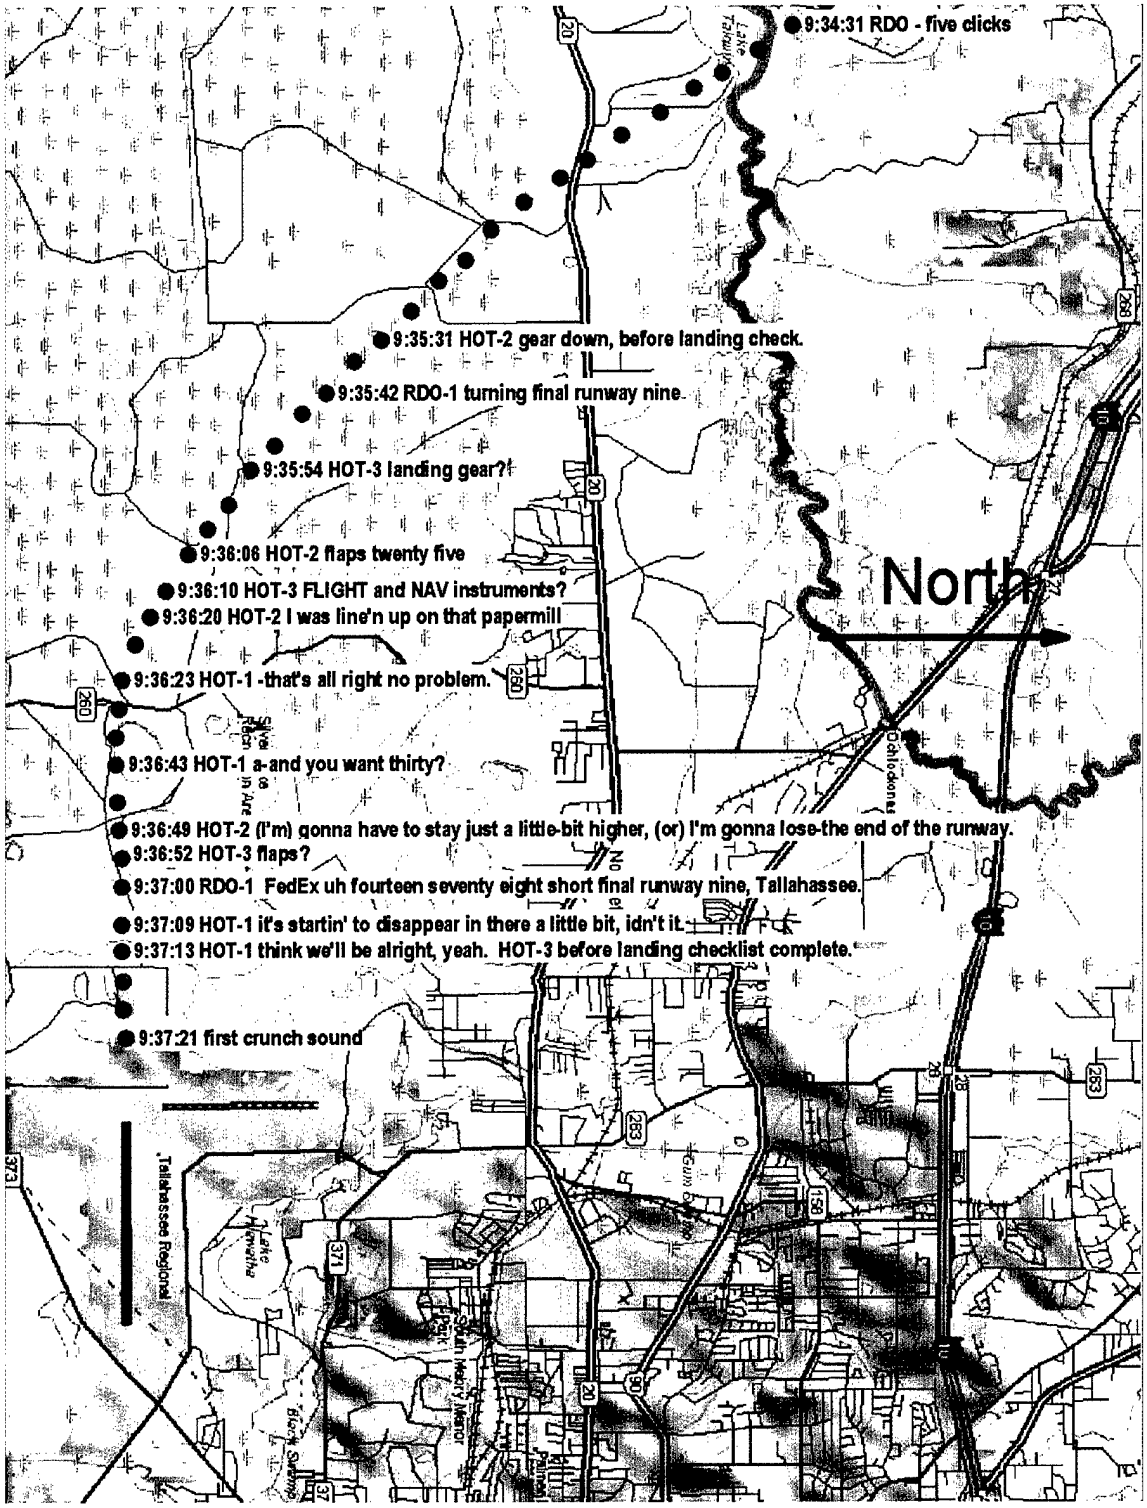
Figure 3. A map overlay of FedEx flight 1478's radar track into runway 9 at TLH, with excerpted CVR comments.

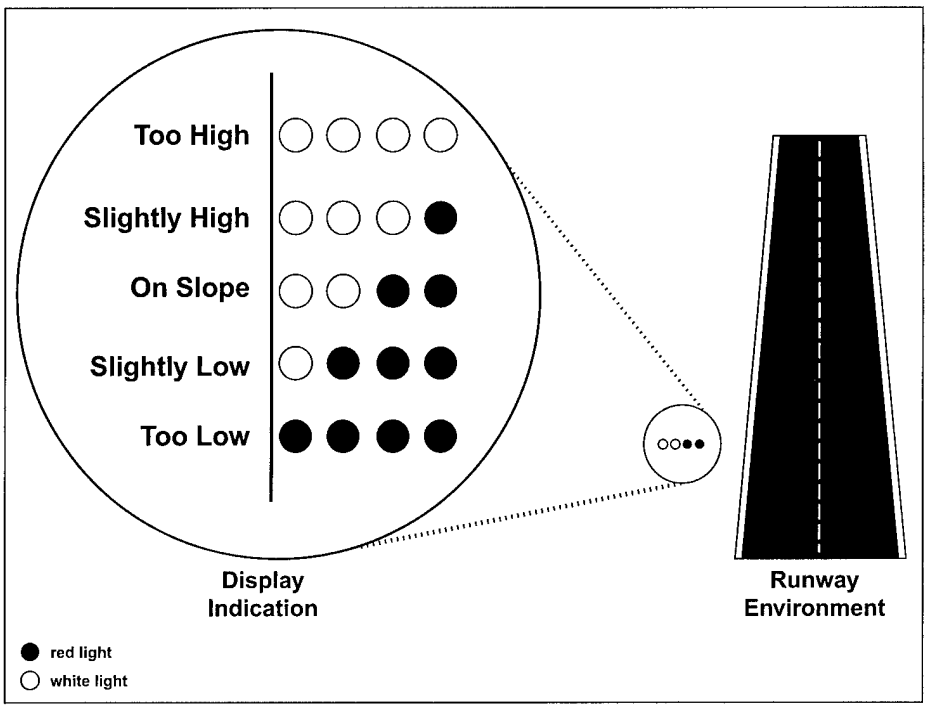
The PAPI lighting system installed on the left side of the approach end of runway 9 was an ADB, ALNACO, Inc. (a subsidiary of Siemens Airfield Solutions) model L-880, style A, and consisted of four identical light boxes mounted along a line perpendicular to the runway centerline about 1,000 feet from the approach end of the runway. Each of the four boxes contained two 200-watt lamps and optical apparatus to split the lamp beams horizontally into red (lower) and white (upper) beams. The lamps in each of the four light boxes were positioned so that each box projected a signal at a prescribed angle above the horizon, relative to a 3° glidepath.[43] An on-glidepath signal is represented by the two left-side boxes showing white lights and the two right-side boxes showing red lights. If an airplane is beneath the glidepath, more red lights would be visible to the pilots; if an airplane is above the glidepath, more white lights would be visible. Figure 6 shows PAPI indications from various approach path angles.

Figure 6. PAPI indications from various approach path angles.
