AFRL-PR-ED-TR-2001-0027

Battery Failure on the Electric Propulsion Space Experiment (ESEX)

November 2001

Special Report

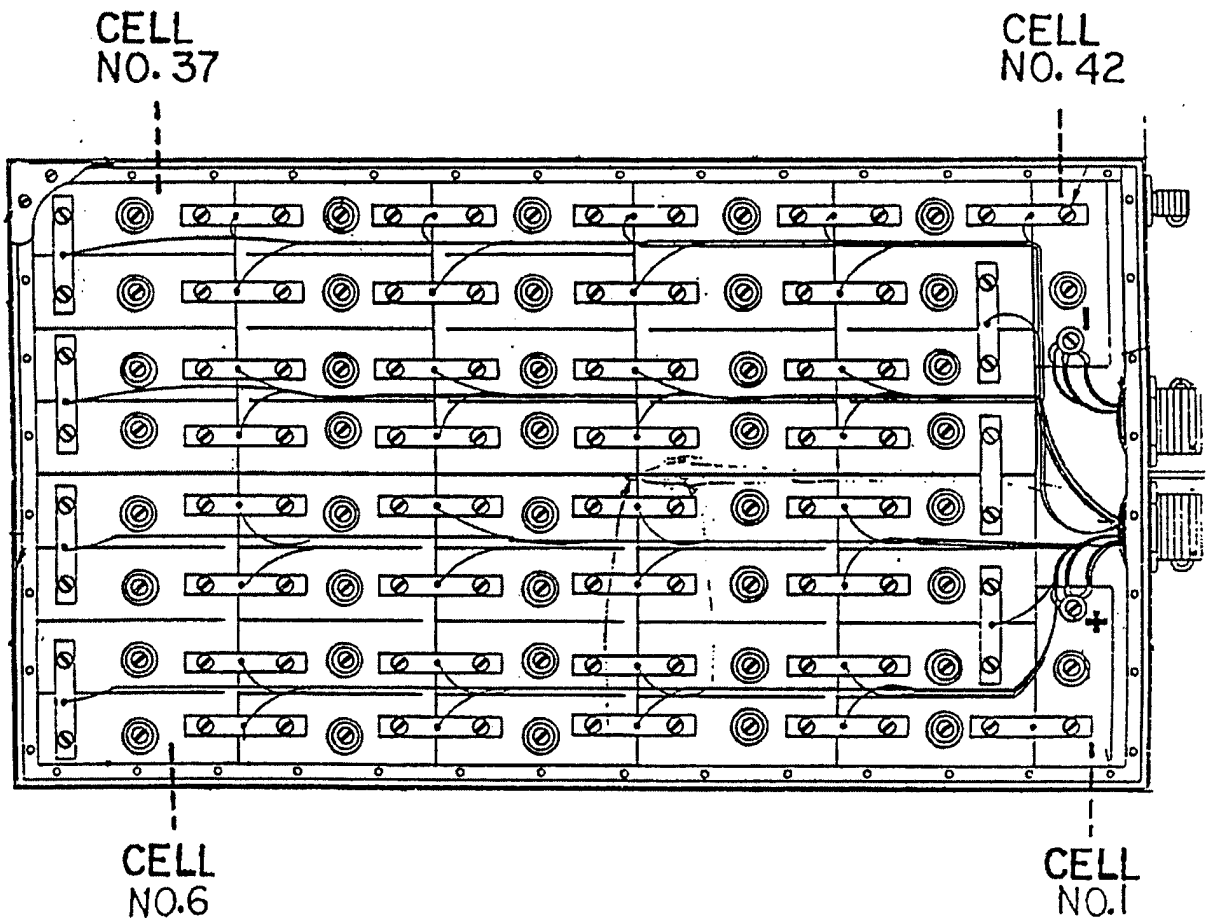
Figure 2. ESEX Battery Sub-Assembly Drawing Showing the Layout for the 42 Cells

layer copper strap (128 straps total, each strap had a resistance of 0.047 mΩ), bolted to the cell terminals. The completed sub-assembly then had a layer of potting encapsulate (FR-88 epoxy filled with microscopic glass beads) over the cells, covering the cell interconnects, leaving only the cell vents open to the interior of the battery sub-assembly chassis. Each sub-assembly also has a relief valve (cracking pressure of 3-8 psi) to vent over-pressure through its mounting panel to the outside of the flight unit.

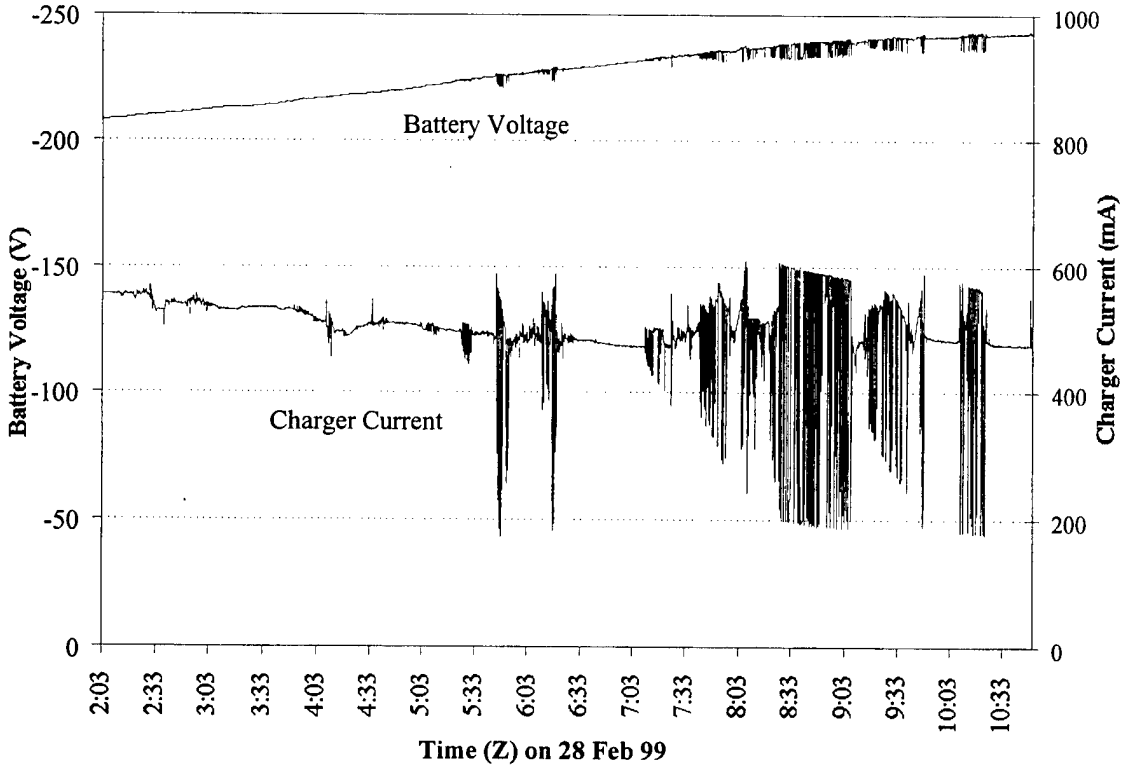
The first signs of anomalous behavior in the battery were observed during the first charging cycle, which was initiated approximately 60 hours after launch.[13] As indicated above, the charger was designed to provide an output current of 0.67 A to the battery. Within nine hours of

Figure 3. Typical Battery Charging Circuit Instability

turn-on, however, the charger output was less than 0.6 A, and decreasing. Although the charging circuit was operating at this lower output current, the charging proceeded nominally and was continued while the data was being monitored. As charging progressed over the next 48 hours, the output current remained stable around 0.57 A until the battery voltage approached -225 Vdc. At this point, as shown in Figure 3, the output current from the charging circuit began cycling on and off, resulting in oscillations of the open circuit battery voltage, charger output current, and even on the ARGOS 28 Vdc main bus current and voltage (not shown here). Initially, this was thought to be a result of higher-than-expected internal battery impedance as the charging progressed and the battery cooled – exacerbated by a low rate of charge. As the battery impedance is increased, the current loop control circuit in the battery charger becomes unstable, and results in the charger cycling on and off. This impedance was determined by taking the ratio of the change in battery voltage to the change in battery charge current. Near the first charging cycle, this impedance was calculated to be approximately 13 Ω – lending further credence to this proposed source of charging instability.

The ESEX failure suggests an electrolyte expulsion problem as was concluded in the write-up. In Figure 3, the first indications of problems are evident. Between 5:33 and 6:03 Z, the battery voltage is seen to drop about 6.0 volts. The granularity of the data appears to be too course to be able to see a short circuit within a single cell. The 6-volt drop suggests a short circuit to ground. In addition, there could have been a short circuit within a cell that actually melted the cell case allowing electrolyte to leak out and form a shorting path to the grounded battery box. That is, the electrolyte path could come from a hole melted in the cell case or from electrolyte being expelled out through the cell vent. Since a hole in the cell case resulted in the failure of the ESEX battery several years ago, this same problem may have initiated the short to the battery box in the flight battery. In Figure 5, the short to ground has grown to a much more significant short circuit. Silver-zinc cells have the capability of extremely high rates of internal discharge during a short circuit inside a cell. They have been known to catch fire during these events. The cell cases are made from combustible plastic materials. At the elevated temperatures of a fire, the silver oxide material will disassociate liberating oxygen that will encourage the fire. All of this thermal energy can produce steam as the electrolyte is heated above its boiling point.

In an attempt to offset this problem and lower the effective charging circuit impedance, high capacitance filters were switched into the circuit via high voltage relays connecting the battery with the PCU.[12] This increased capacitance improved the charger performance, but did not eliminate the fluctuations. Since the output current instability was not detrimental to the ESEX battery or the spacecraft bus, charging was performed through this region. The total charging time was then increased to compensate for the charging inefficiencies resulting from the cycling output from the charger.

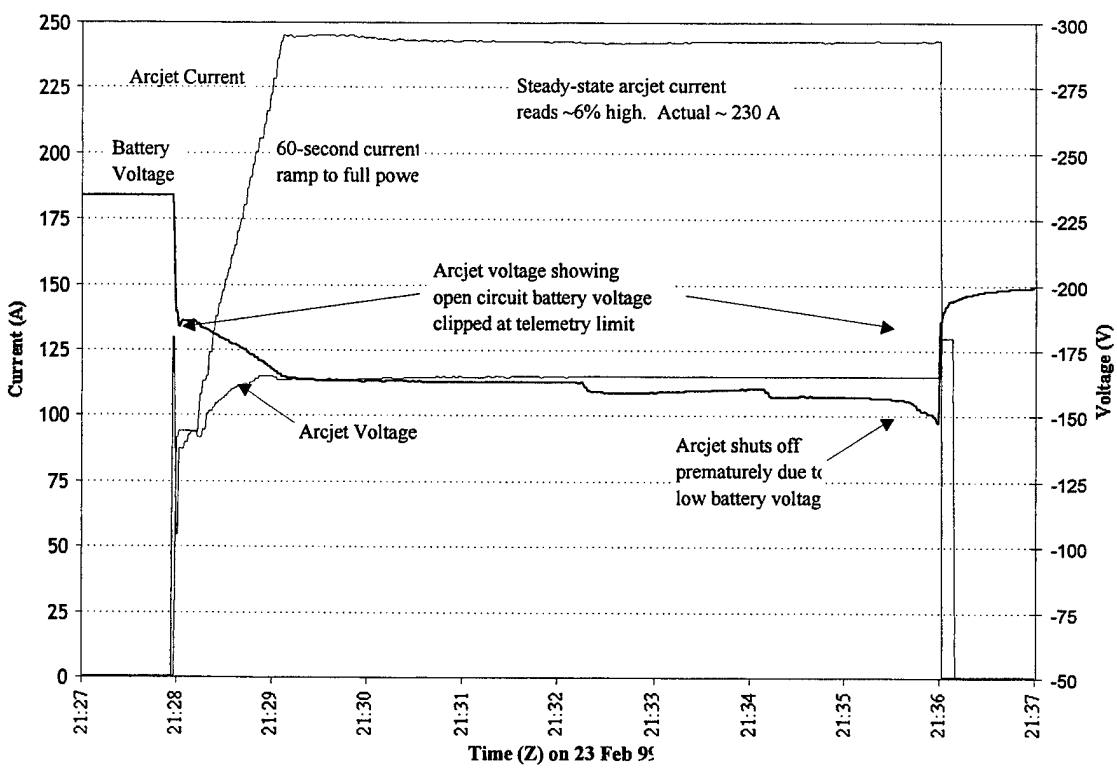
Beginning on firing #4, however, a decrease in the battery output voltage was observed that limited the total firing duration. As shown in Figure 4, this drop in output voltage resulted in

Figure 4. Example of a Premature Arcjet Firing Shut-off as a Result of the Low Battery Output Voltage. Data is Taken from Firing #4.

unstable PCU and arcjet operation, and eventually extinguished the thruster. The duration of each firing from #4 through #8 steadily decreased from 482 seconds to 42 seconds, as the battery performance deteriorated. After firing #7, an attempt to recondition the battery was made by performing a deep discharge through the existing bleed resistors, and restarting the charge. The initial plan was to wait until the battery was at a full state of charge (indicated by the charger circuit shutting off at the upper voltage limit) before attempting the next firing. After more than 19 days, however, the charger was commanded off and a firing was attempted. As indicated above, the duration of firing #8 showed the reconditioning did not have the desired effect.

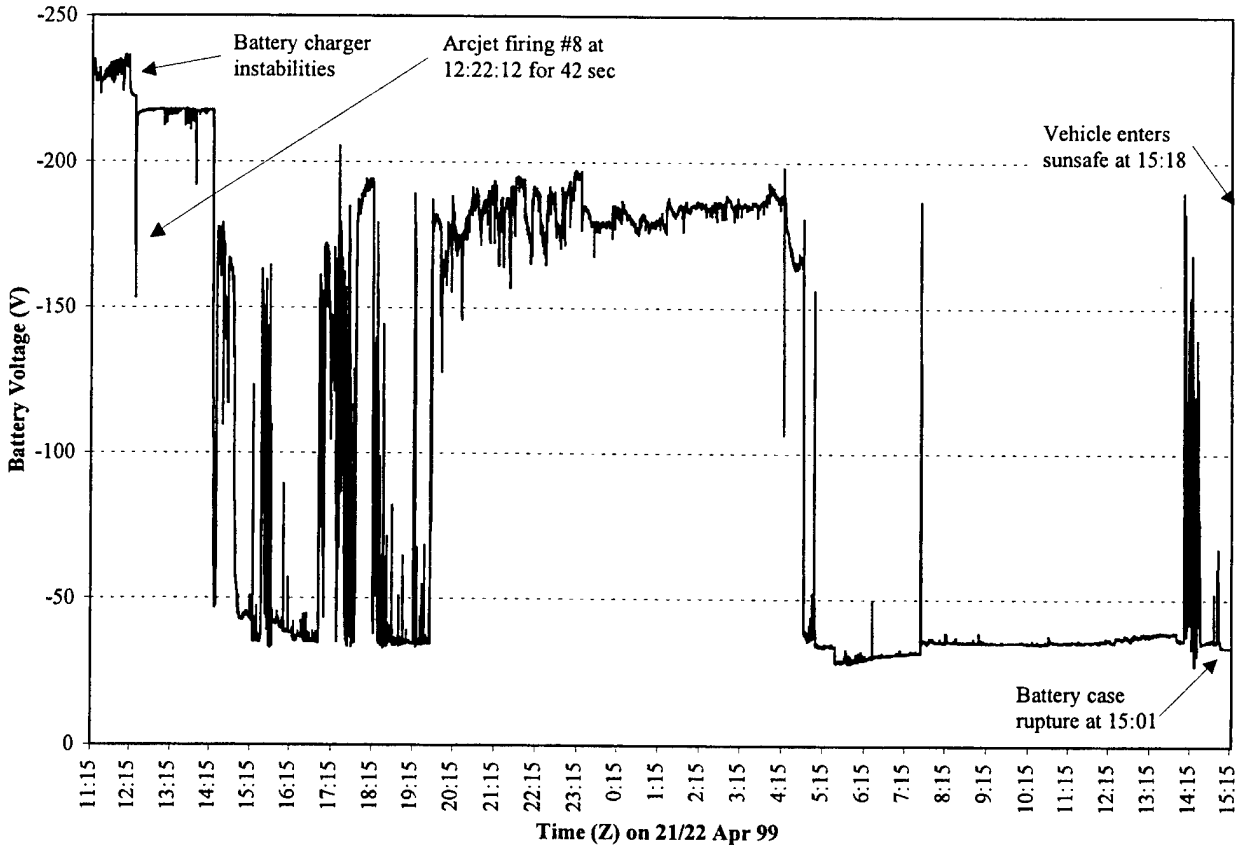
Following firing #8, the battery voltage fluctuated erratically between -175 and -200 Vdc with periodic drops as low as -30 Vdc – where it eventually stabilized, as shown in Figure 5. This behavior lasted approximately 24 hours until the battery sub-assembly on panel #1 had a catastrophic failure as a result of a short circuit. As the energy in the cell was discharging internally through the short circuit, there was a dramatic increase in the battery temperature and pressure as hydrogen gas was being generated from electrolyte decomposition. This process continued until there was a breach of the battery case and a release of this super-heated gas internal to the ESEX flight unit on 22 Apr 99 at 1501 Z. This gas release was likely directed at panel #3, since a 40 °F increase in temperature on this panel was observed over the course of a few seconds. This gas was eventually vented into space, causing a dramatic attitude disturbance

Figure 5. Battery Voltage Fluctuations Following the Final Arcjet Firing (#8) Ultimately Resulting in the Short Circuit
